The Imaging Source Helpdesk

Unable to focus with C or CS mount lens, blurry, unsharp images

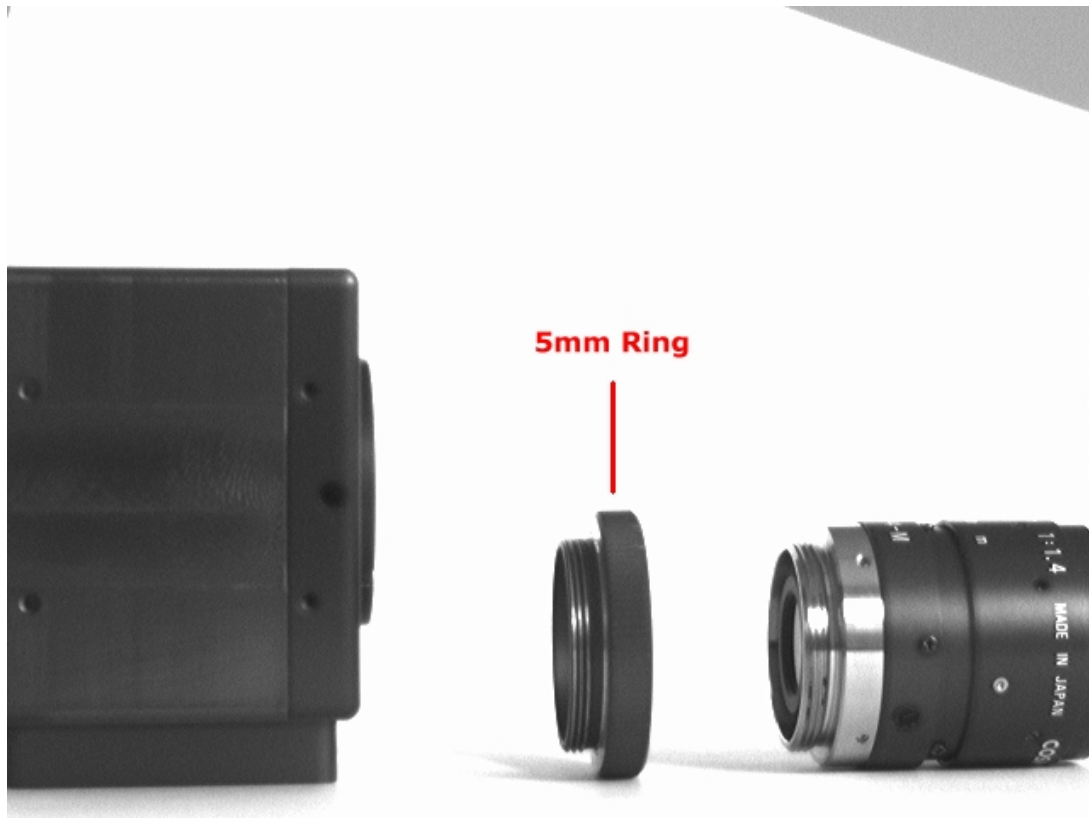
The The Imaging Source cameras are provided with a 5mm distance ring from factory. This ring is needed, if a C-mount lens is in use. If a CS-mount lens is used, then this 5mm distance ring has to be removed. If this is done wrongly, then only unsharp, blurry image are provided and it is impossible to focus.
