The Imaging Source Helpdesk

Unable to focus with C or CS mount lens, blurry, unsharp images

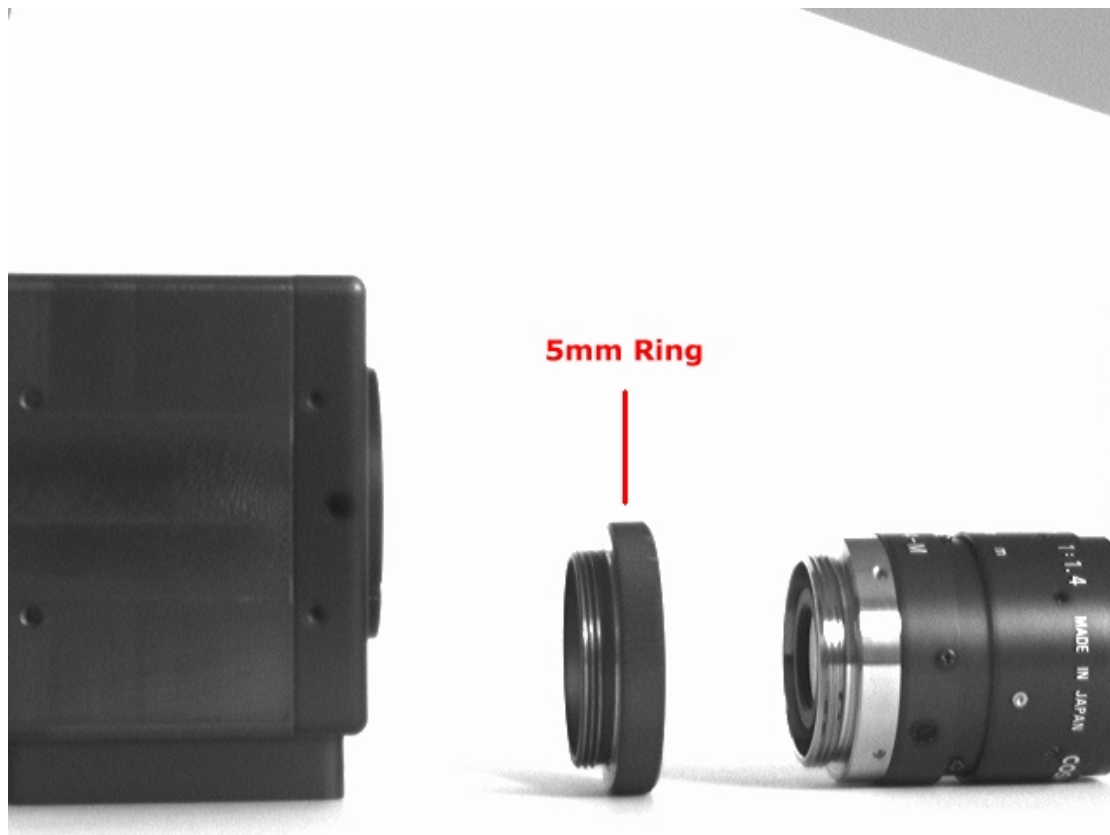
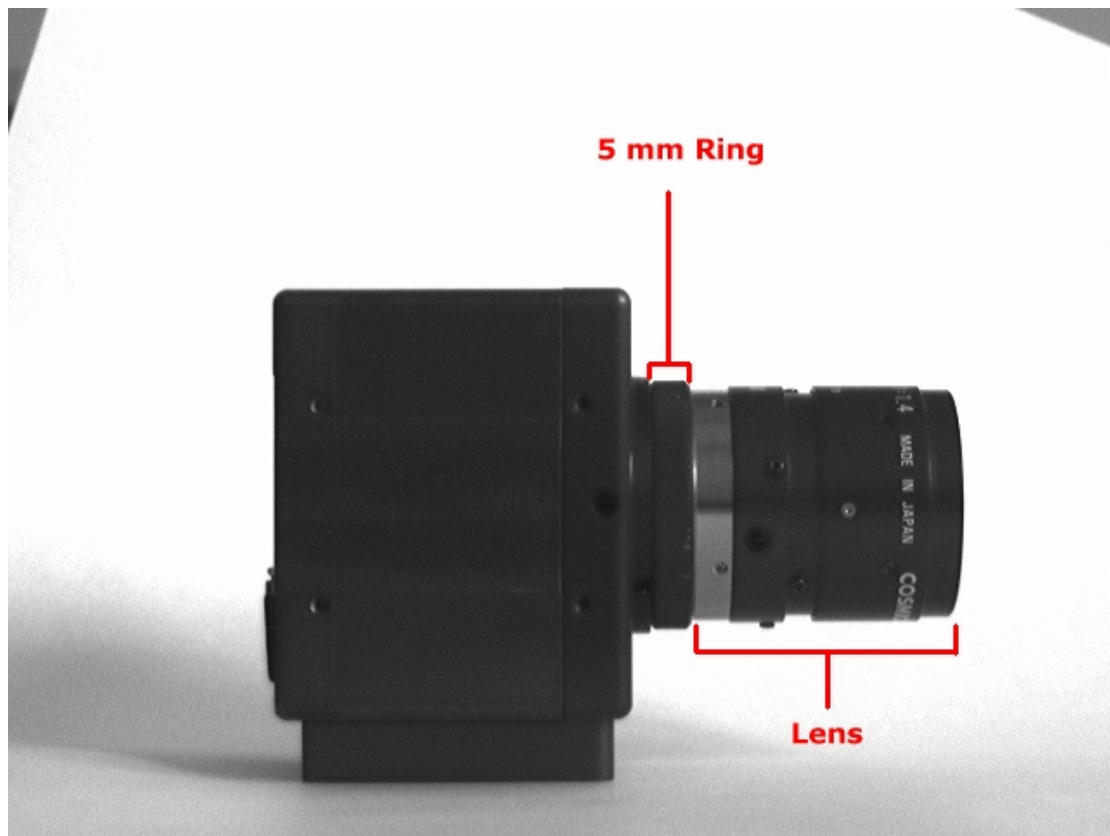
The The Imaging Source cameras are provided with a 5mm distance ring from factory. This ring is needed, if a C-mount lens is in use. If a CS-mount lens is used, then this 5mm distance ring has to be removed. If this is done wrongly, then only unsharp, blurry image are provided and it is impossible to focus.

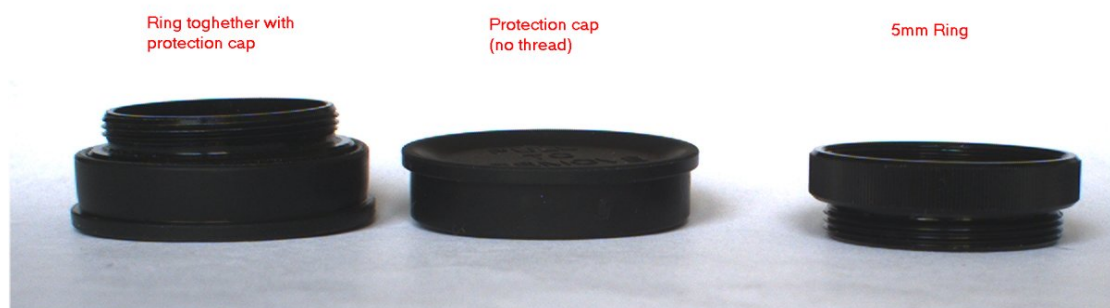
It can happen that the ring is removed together with the protection cap from the camera:

The "Ring together with protection cap" shows, how it looks like if the 5mm Distance ring was unscrewed with the protection cap from the camera. The both parts in the middle and right side show, how the cap and the 5mm ring are separated.
