The Imaging Source Helpdesk

Unable to focus with C or CS mount lens, blurry, unsharp images

S.Geißler - 2019-09-25 - Fehlerbehebung

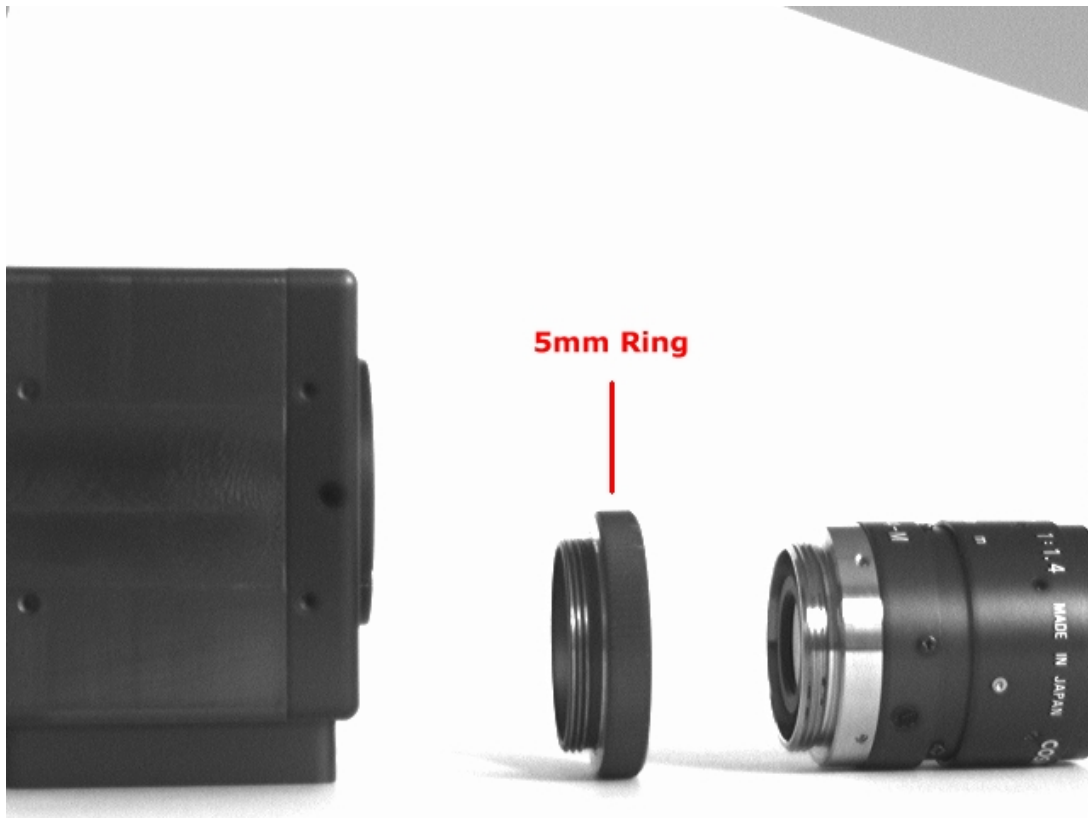
The The Imaging Source cameras are provided with a 5mm distance ring from factory. This ring is needed, if a C-mount lens is in use. If a CS-mount lens is used, then this 5mm distance ring has to be removed. If this is done wrongly, then only unsharp, blurry image are provided and it is impossible to focus.
