Unable to focus with C or CS mount lens, blurry, unsharp images

S.Geißler - 2019-09-25 - in Troubleshooting

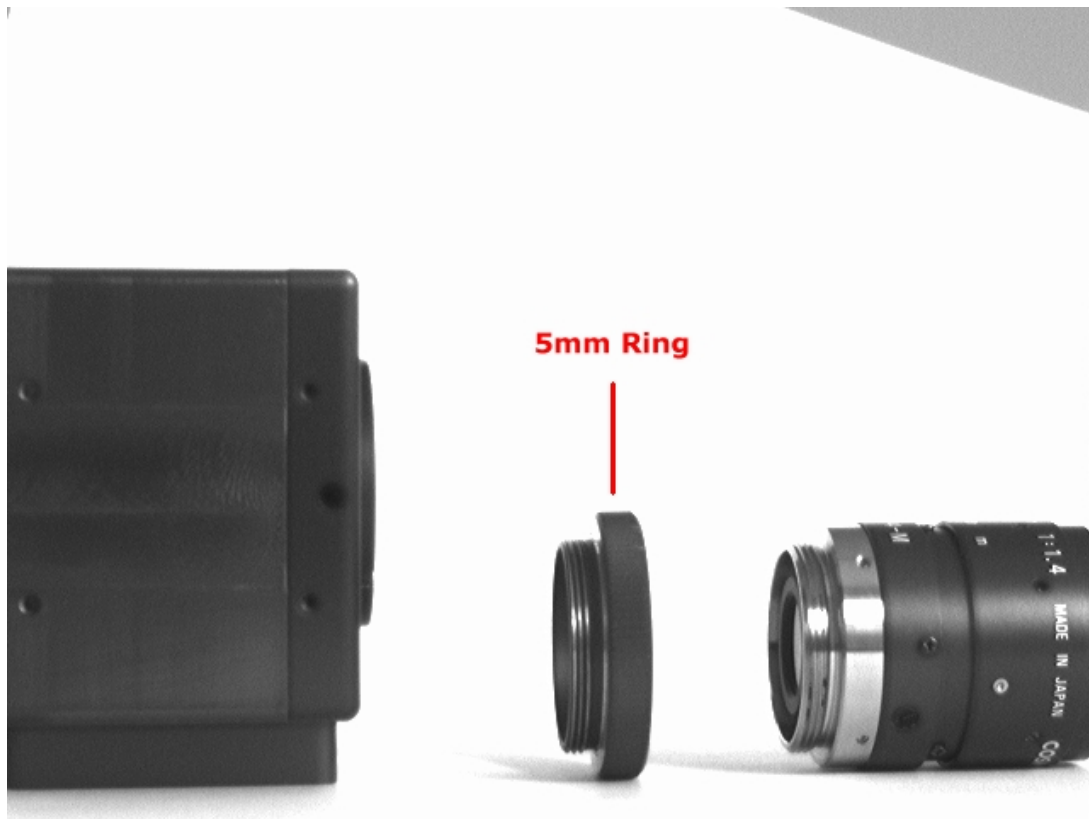
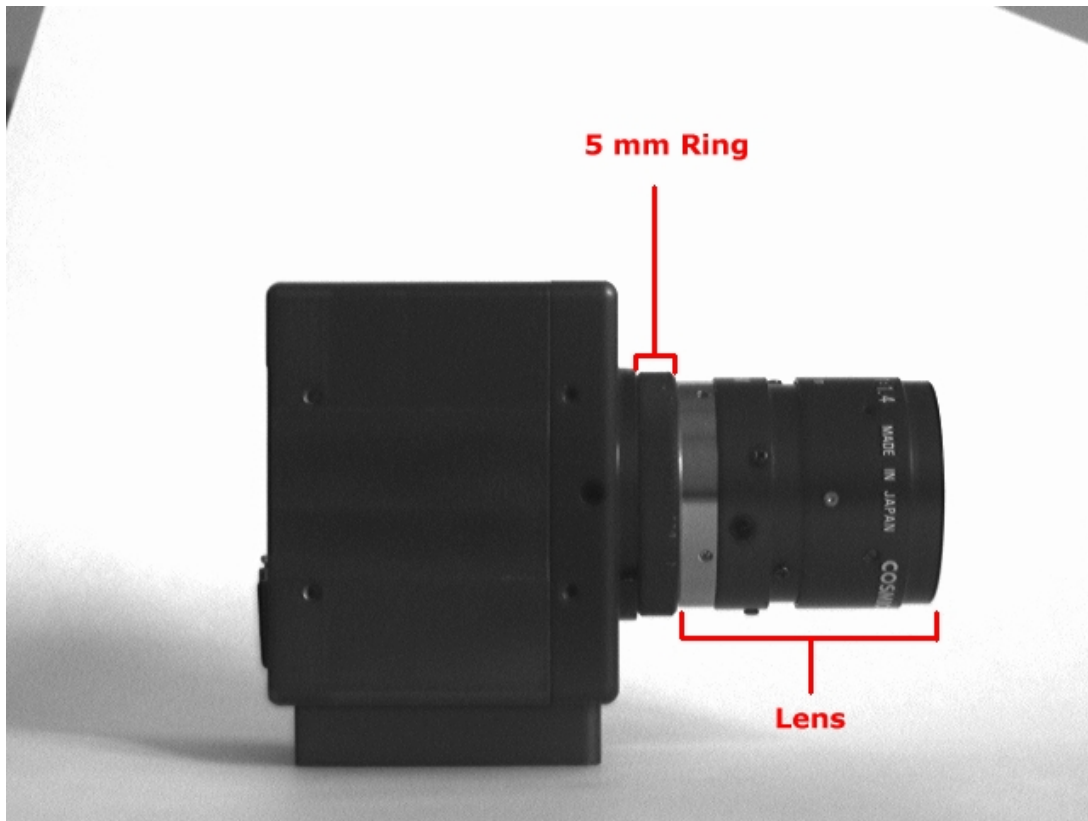
The The Imaging Source cameras are provided with a 5mm distance ring from factory. This ring is needed, if a C-mount lens is in use. If a CS-mount lens is used, then this 5mm distance ring has to be removed. If this is done wrongly, then only unsharp, blurry image are provided and it is impossible to focus.

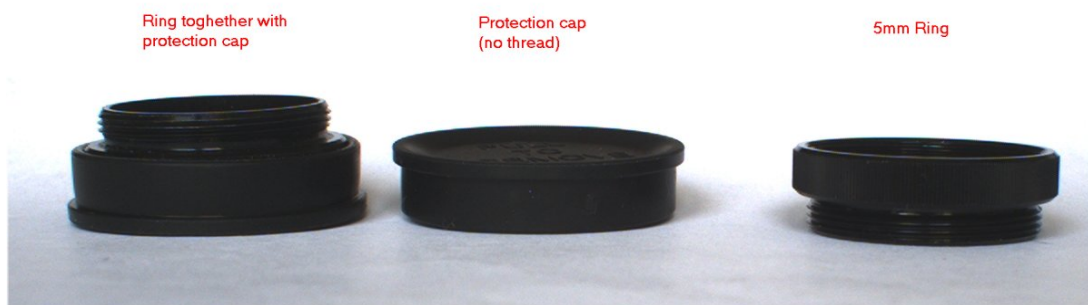
It can happen that the ring is removed together with the protection cap from the camera:

The "Ring together with protection cap" shows, how it looks like if the 5mm Distance ring was unscrewed with the protection cap from the camera. The both parts in the middle and right side show, how the cap and the 5mm ring are separated.
